Headstone Stability Load Tests

Site Address: Union Point, Uckfield, East Sussex

Client: Stone-Safe

Project Reference: J9676

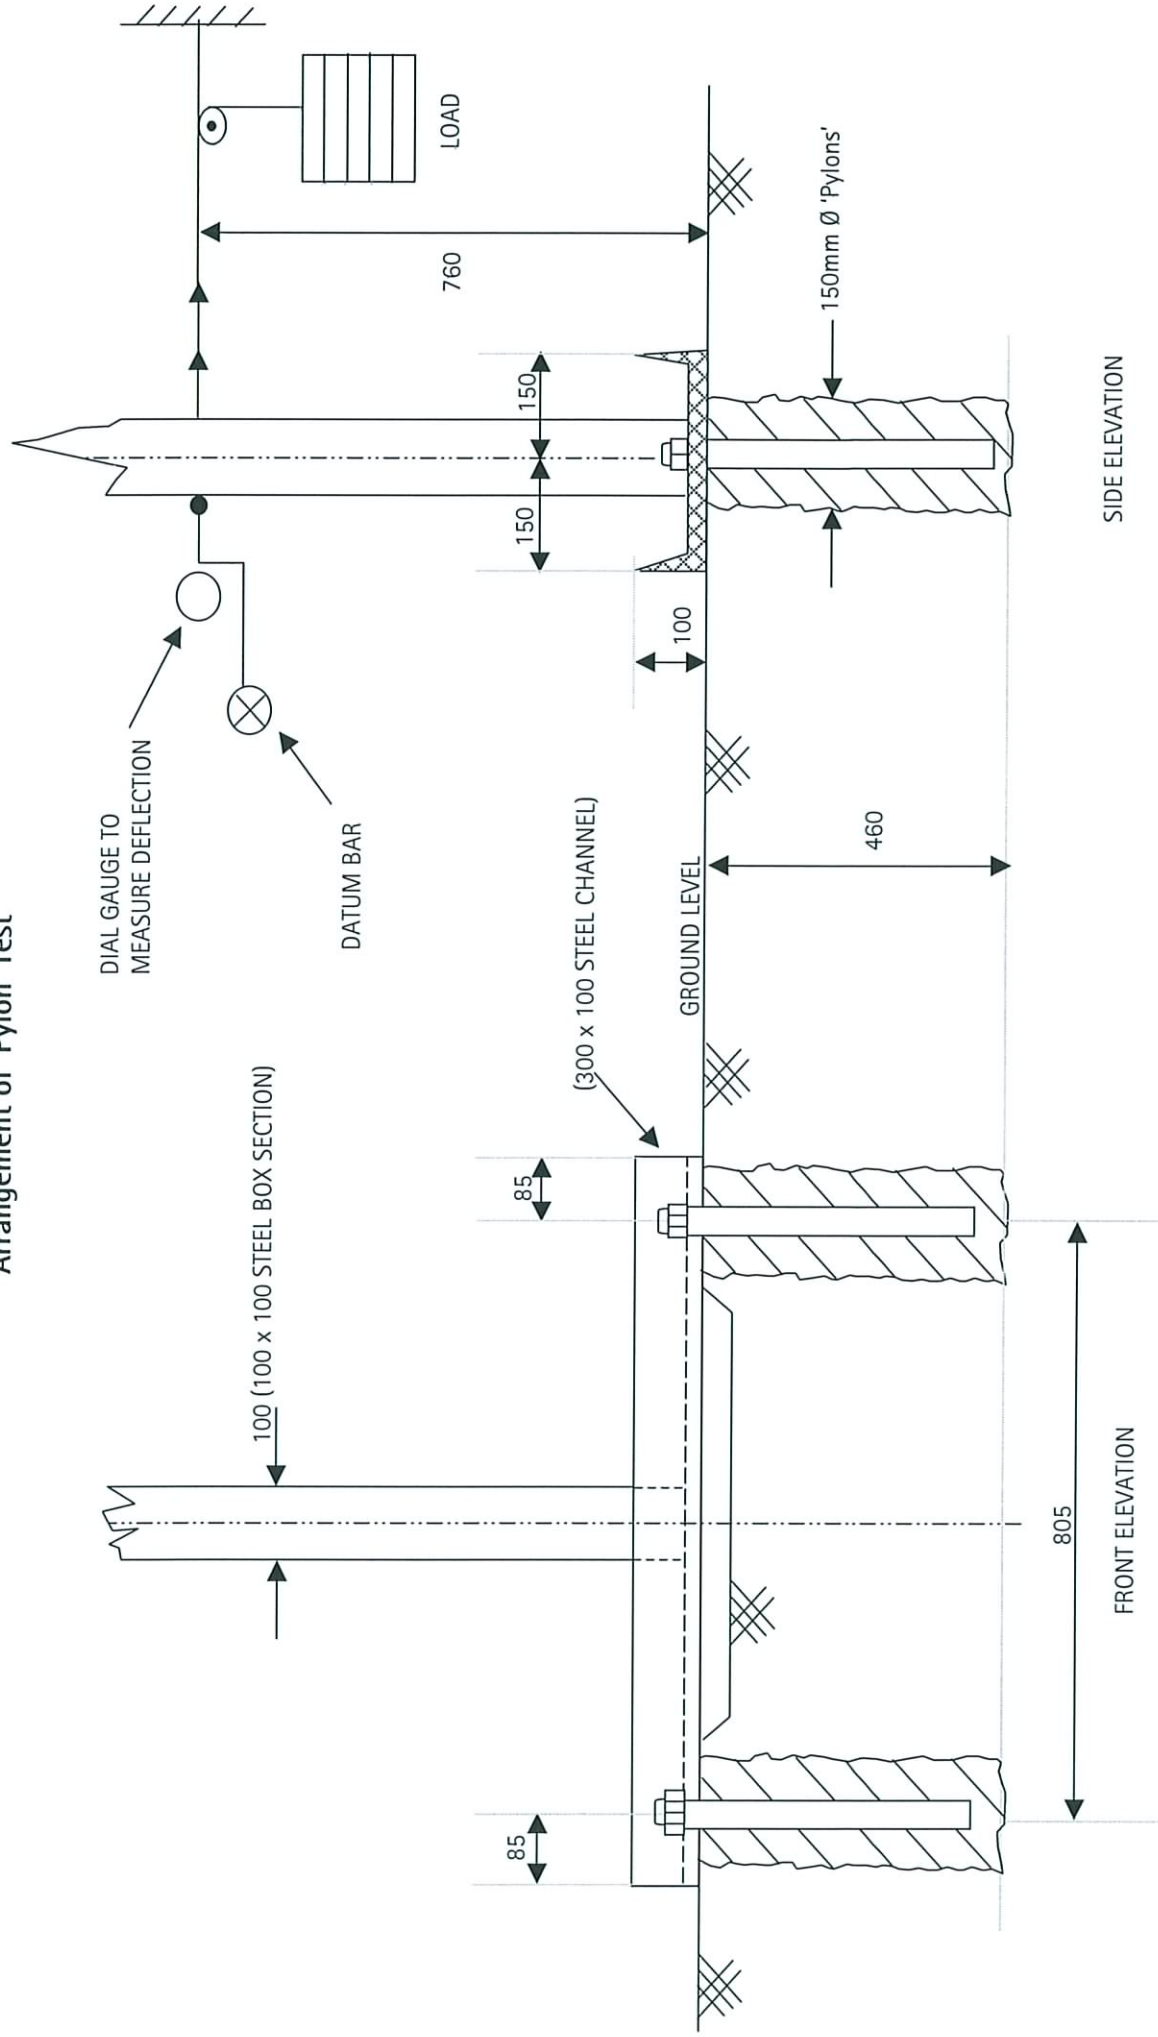
Fig No: A

Arrangement of 'Pylon' test
(Not to scale)

A steel load frame was designed and manufactured by Southern Testing, *Stone-Safe* and C.J. Thorne & Co. Ltd. Civil Engineering Contractors. The frame was designed to model a foundation slab and to allow a horizontal pull to be applied. The test arrangements are shown in Figures A and B. The lateral load was applied to a vertical steel box channel welded onto a steel channel forming the base of the load frame. The horizontal load was applied to the vertical steel box section at a height of 2' 6" above ground level using calibrated weights placed on a hanger system. The resulting deflection at the point of "horizontal pull" was measured using a dial gauge (0.01mm/division) connected to a horizontal datum bar.

To allow the concrete of each pile to cure, approximately one week prior to the tests being carried out a representative from *Stone-Safe* installed their "pylon" foundation system into the three soil types to be tested. To model the cranked foundation base, the soil was removed from beneath the base of the load frame between the two piles. The load frame was then bolted down onto the head of the two "piles" using the threaded rods protruding from the top of each "pile" (refer Figure A).

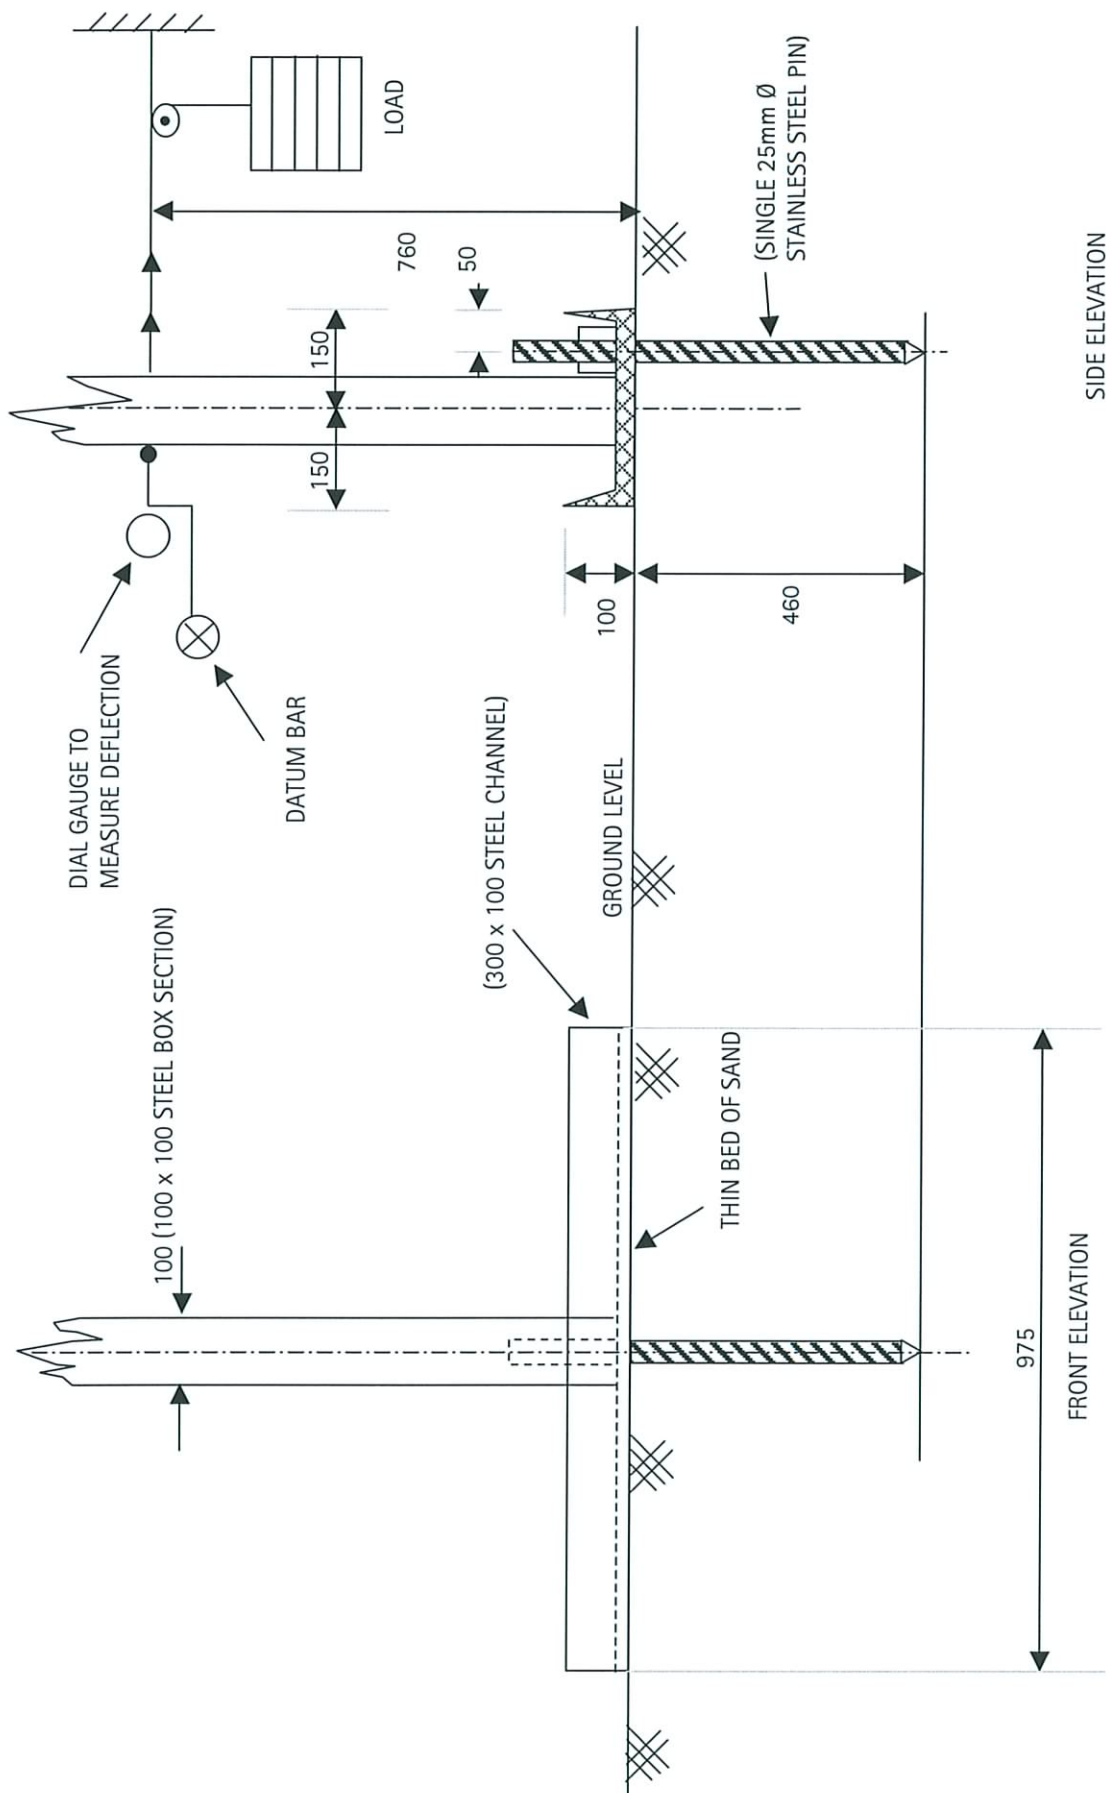
Site: Union Point, Uckfield		STL: J9676	Fig No: B
Date: 15 August 2008		Arrangement of 'Pin' test (Not to scale)	
Southern Testing

Arrangement of 'Pin' Test

In the case of the "pin" system, Southern Testing placed down a thin bed of sand to remove any unevenness between the steel channel base (typically less than 10mm thick) and the test soil formation. The load frame was then firmly bedded down onto the formation by "rotating" the frame on the sand bed. The pin was then driven through a hole in the frame into the underlying soil (refer Figure B).

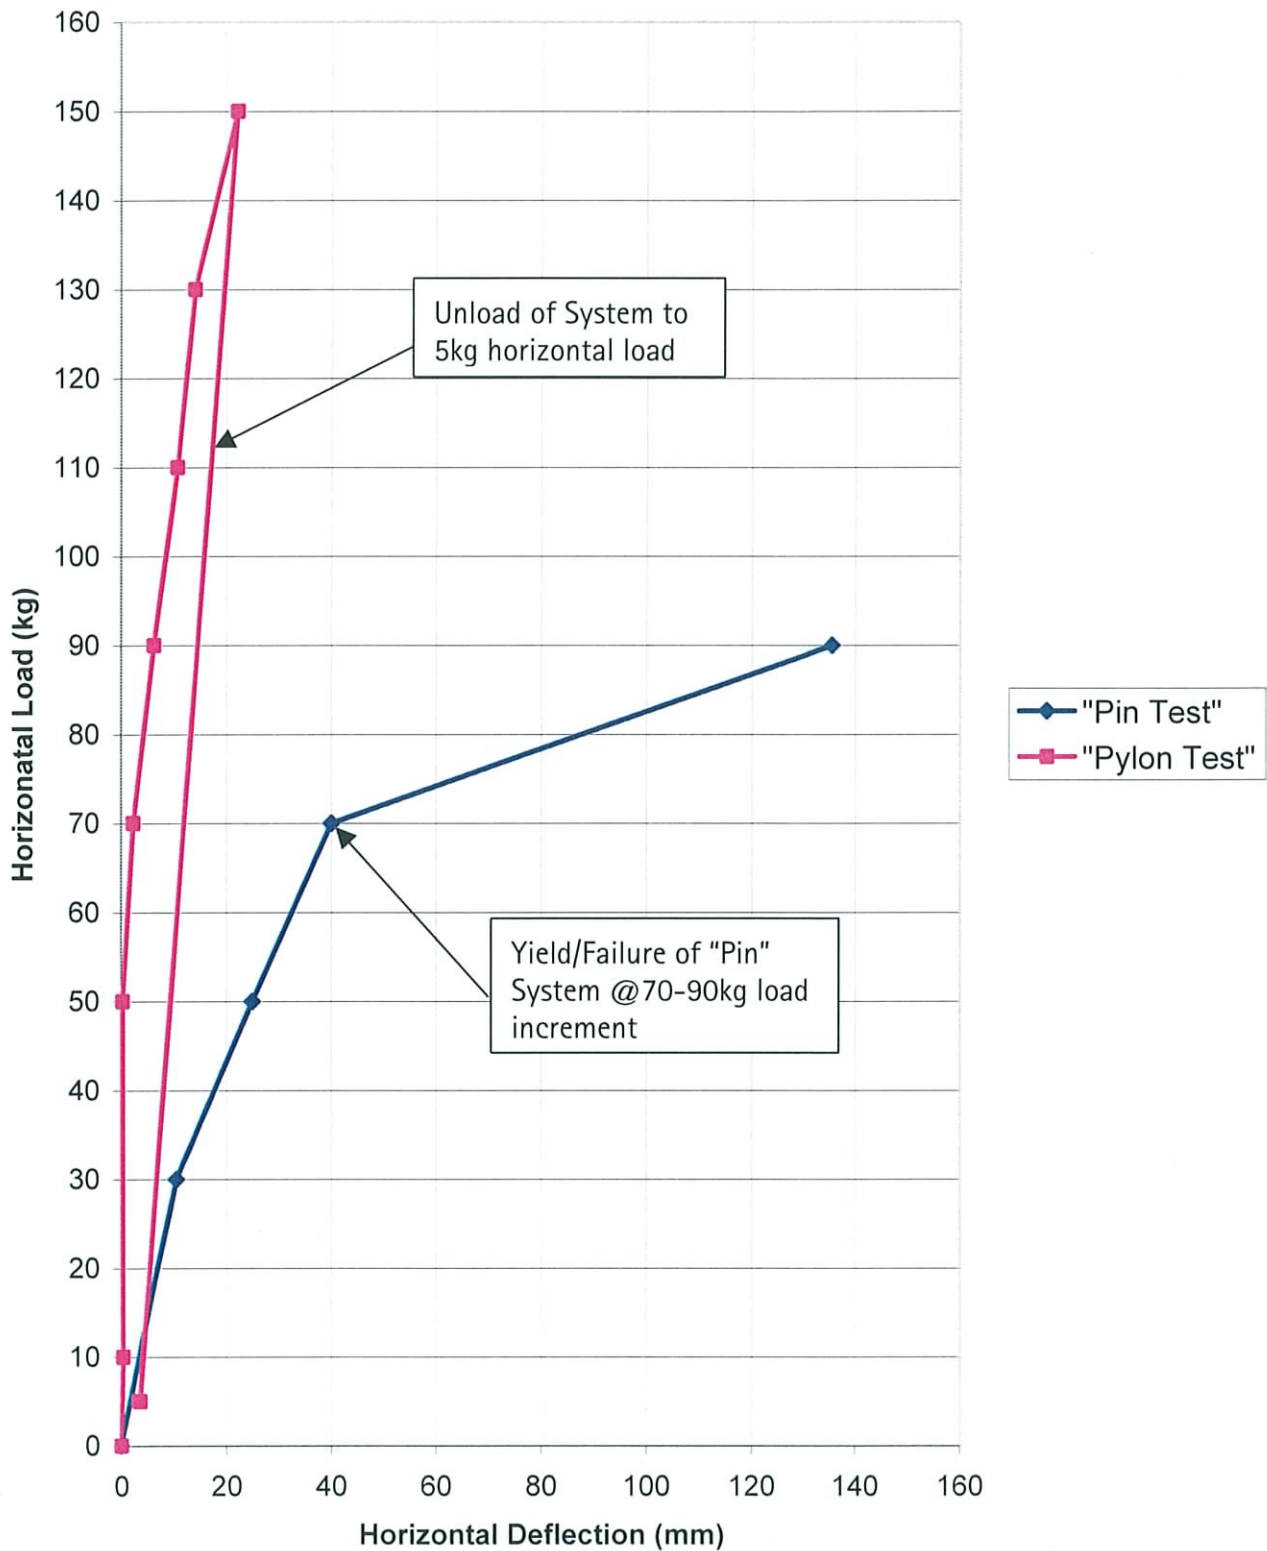
Fig No: 1

Lateral Load Test for Natural Clay Condition

The results of the six load tests and the load-deflection plot for the frame are given in Figures 1A-6A and Figure I. In addition Figures 1-3 are also given that provides a direct comparison of load deflection characteristics for the two foundation systems considered and three soil types investigated.

Referring to Figures 1-3, a summary of the load-deflection behaviour is given below:

Soil Type	Foundation System	Deflection (mm) @ 50kg and 150kg horizontal loads		Yield/Failure of the System and Remarks
		50 kg Load	150kg Load	
Natural Clay ($C_u=250\text{kPa}$)	"Pylon" System	0.3	22	No yield/failure observed. Slight residual deformation of 4mm on unloading was recorded
	"Pin" System	25	Failure of system @70-90kg load increment	Probable onset of yield of the system occurred at the 30-50kg load increment. Failure of the system occurred at the 70-90kg load increment.
Remoulded Clay ($C_u=38\text{kPa}$)	"Pylon" System	0.3*	16	No failure observed. Possible onset of yield @110-150kg loads increment. Residual deformation of 11mm on unloading was recorded
	"Pin" System	57 (Yield of system @30-50kg load increment)	N/A	Yield/failure of system occurred @30-50kg load increment. Test continued until 90kg when complete failure occurred.
Very Loose (dry) Sand (Perth "N"=3)	"Pylon" System	11	Failure of system @130-150kg load increment

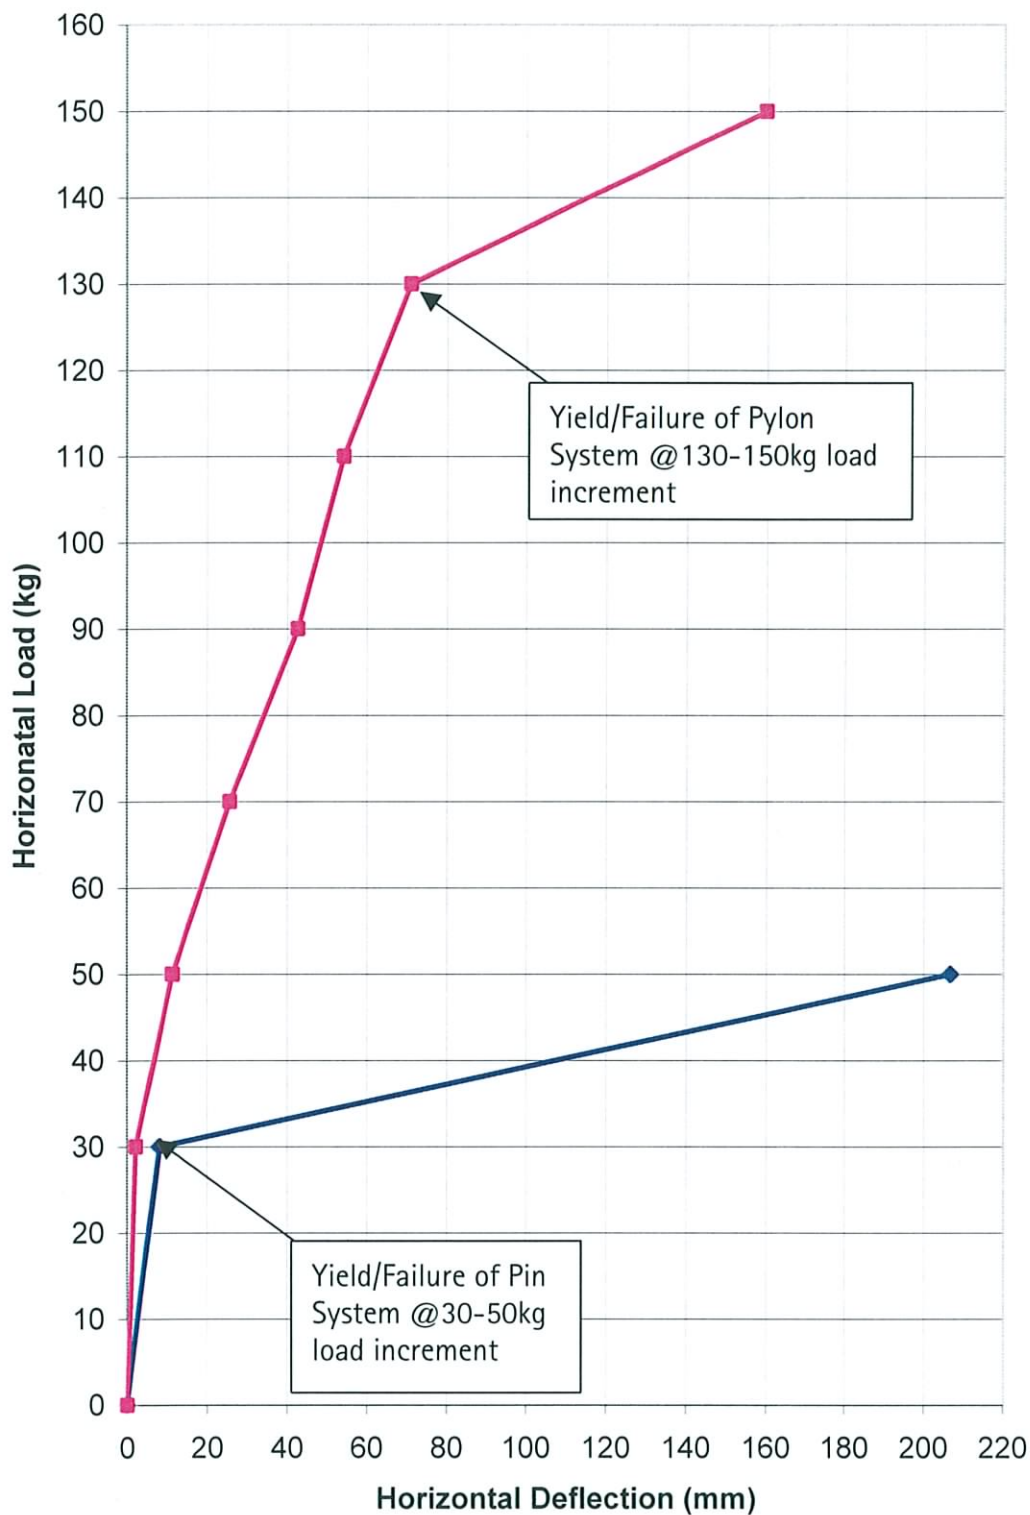
Fig No: 3

Lateral Load Test for Loose Sand Condition

It should be noted that in the case of a very loose sand condition, a minimum pile depth of 2.2' (670mm) is indicated. This is consistent with the findings of the full scale tests where the "Pylon" system effectively failed at a load increment of 130-150kg. Accordingly in cohesionless soils it would be prudent to adopt a minimum pile depth of at least 670mm for very loose cohesionless soils reducing to 550mm for very dense soil conditions.

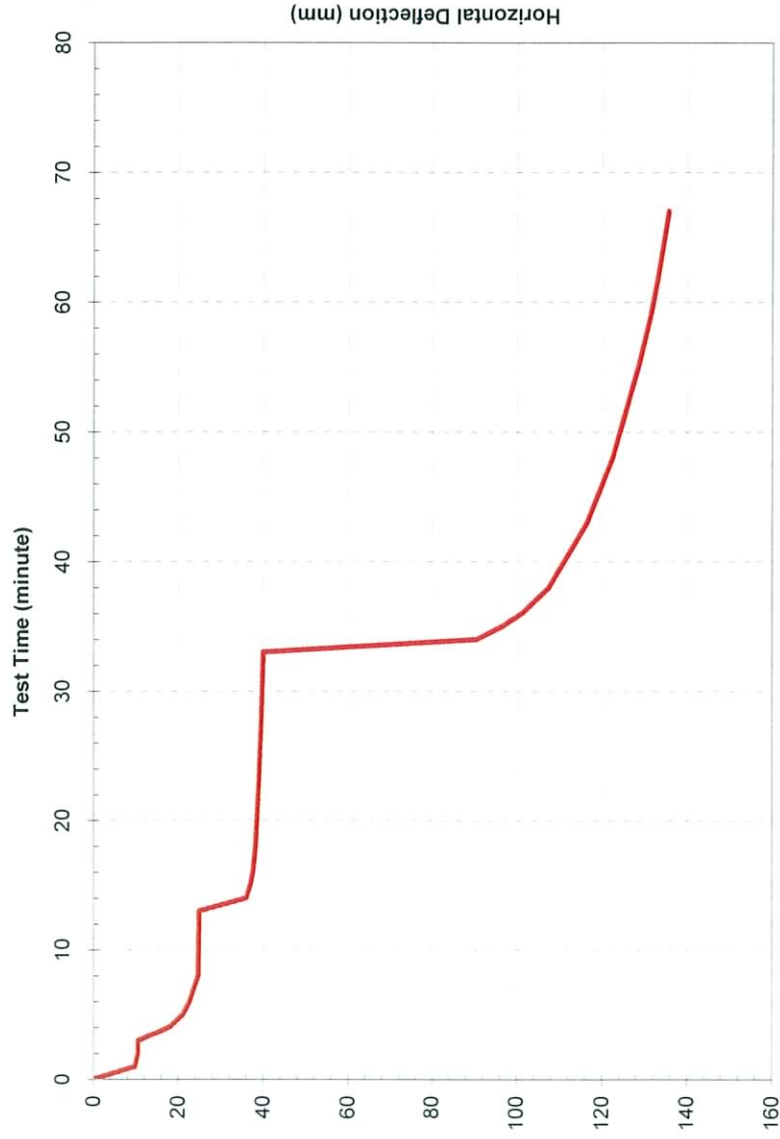
Test No: 1

Horizontal Load Test Results

Soil Type & Condition: Natural Clay

Test Type: Driven pin at front of load frame

Horizontal Deflection vs Test Time

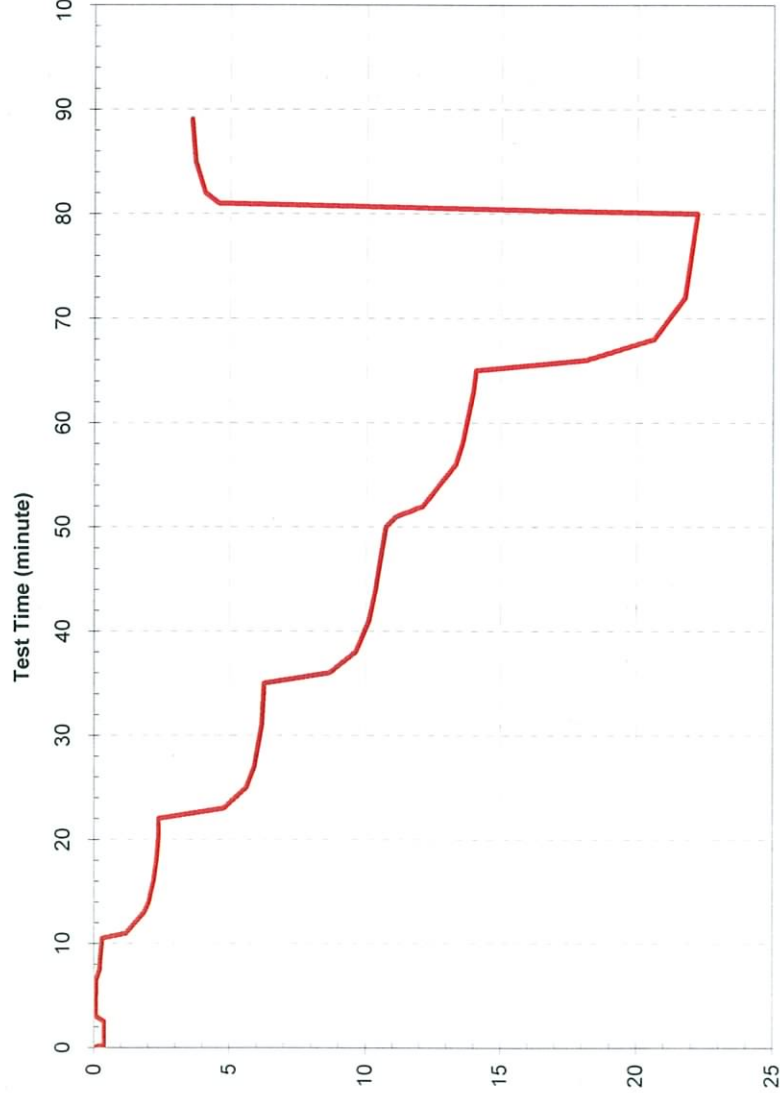
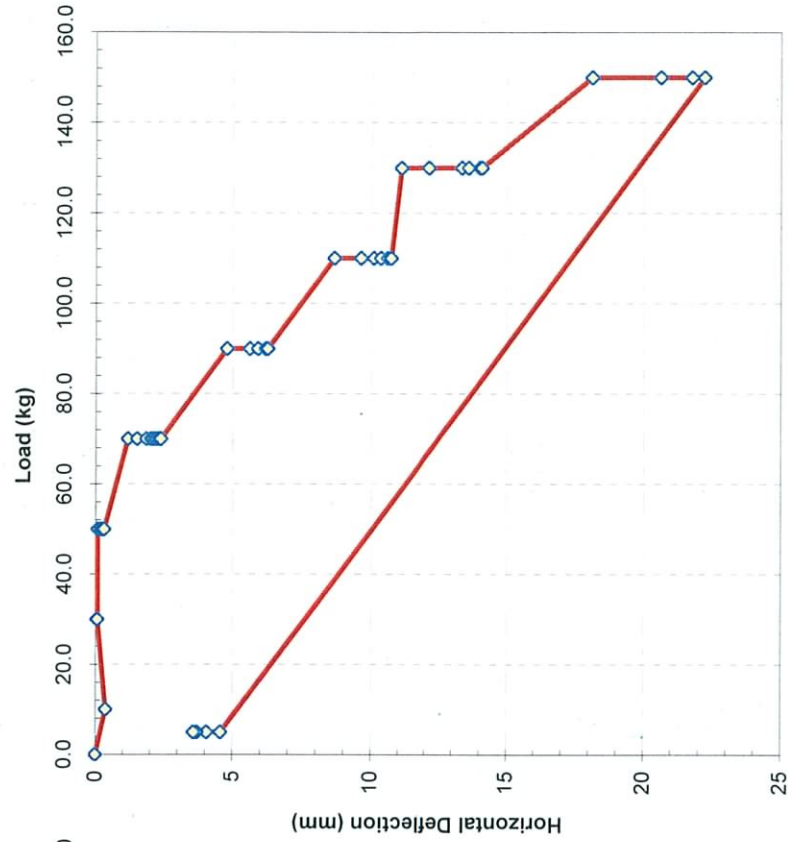
Figure No: 2A

Horizontal Load Test Results

Soil Type & Condition: Natural Clay

Test Type: 18" "Pylons"

Horizontal Deflection vs Test Time

Horizontal Deflection vs Load

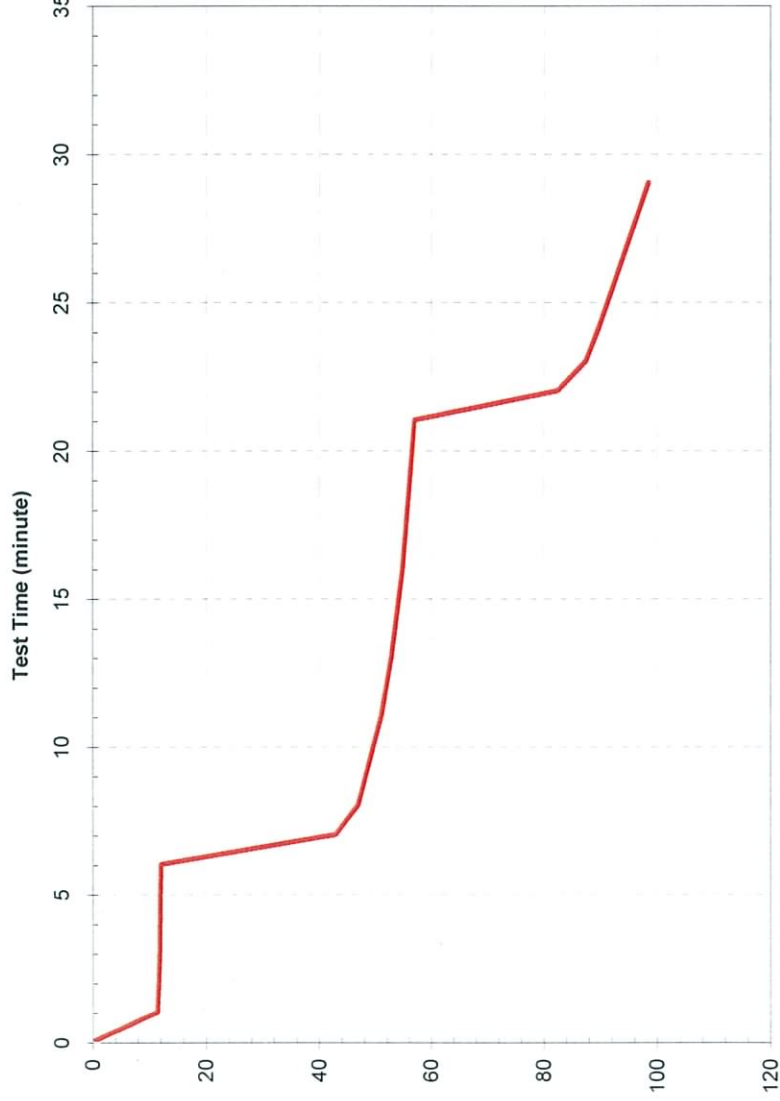
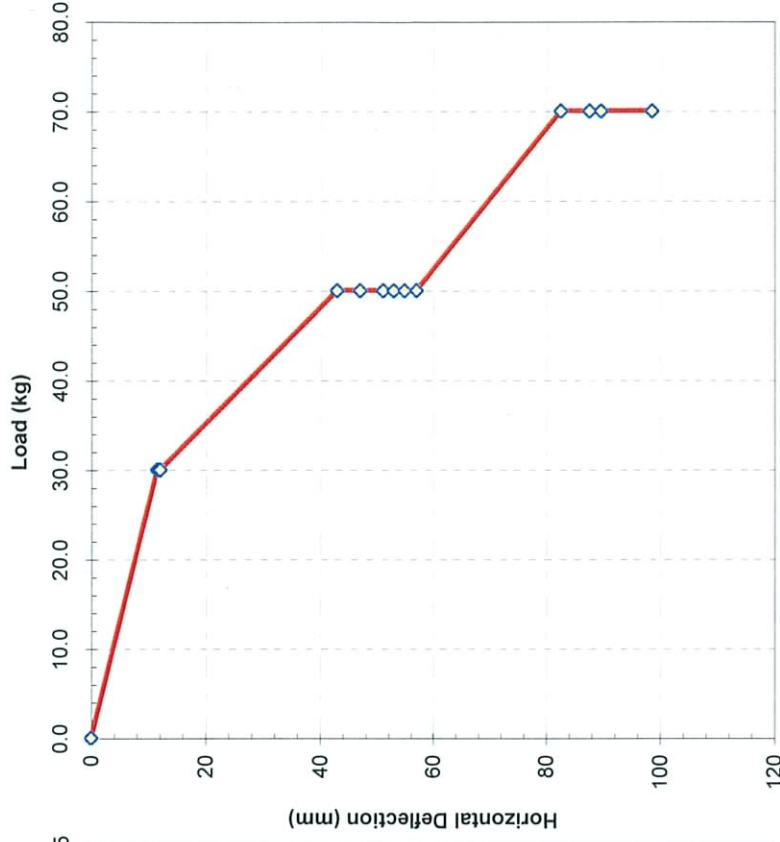
Figure No: 3A

Horizontal Load Test Results

Soil Type & Condition: Remoulded sandy clay
Weather & Temperature: Sunny 30 C
Test Type: Driven pin at front of load frame
Notes:

Horizontal Deflection vs Test Time

Horizontal Deflection vs Load

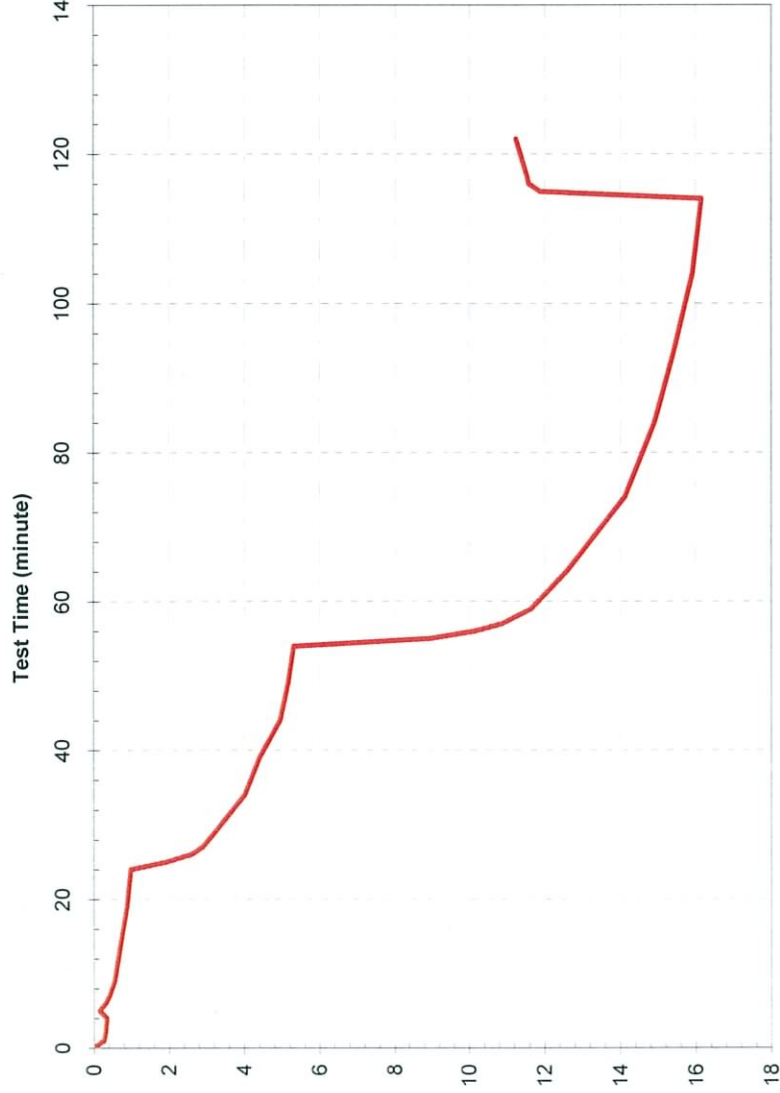
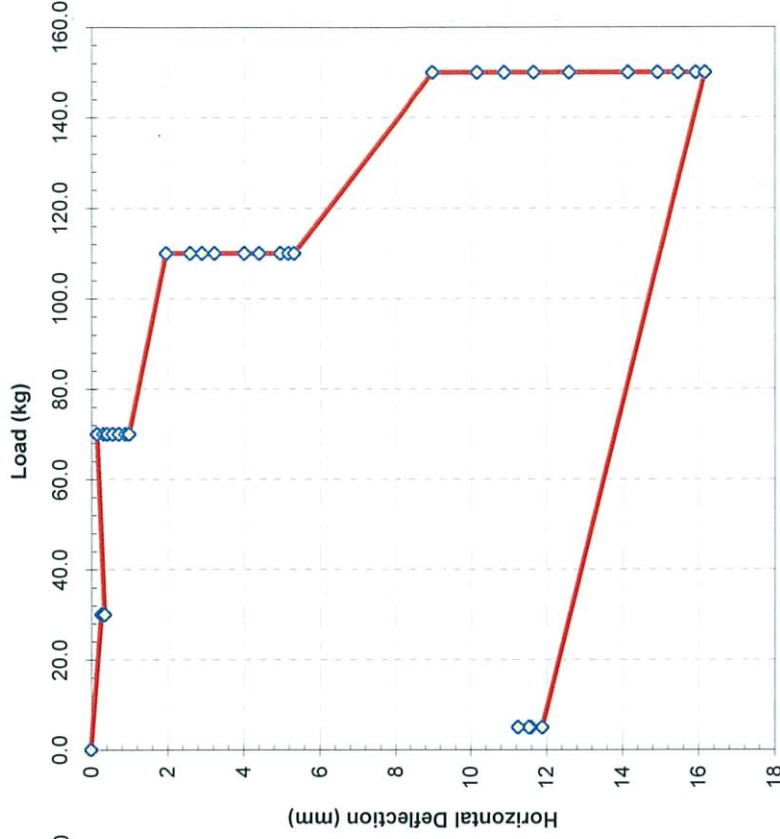
Job No:	J9676
Date:	13/Aug/2008
Checked By:	
Figure No:	4A

Horizontal Load Test Results

Soil Type & Condition: Remoulded sandy clay
Weather & Temperature: Sunny 30 C
Test Type: 18" Pylons
Notes:

Horizontal Deflection vs Test Time

Horizontal Deflection vs Load

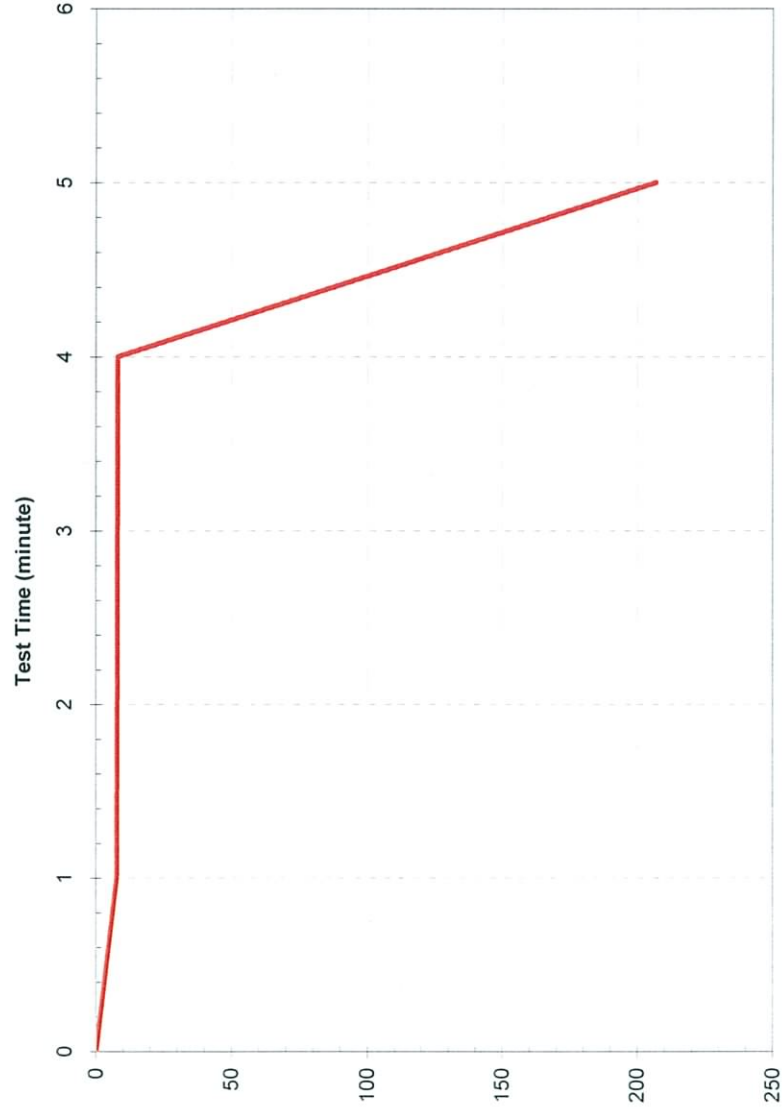
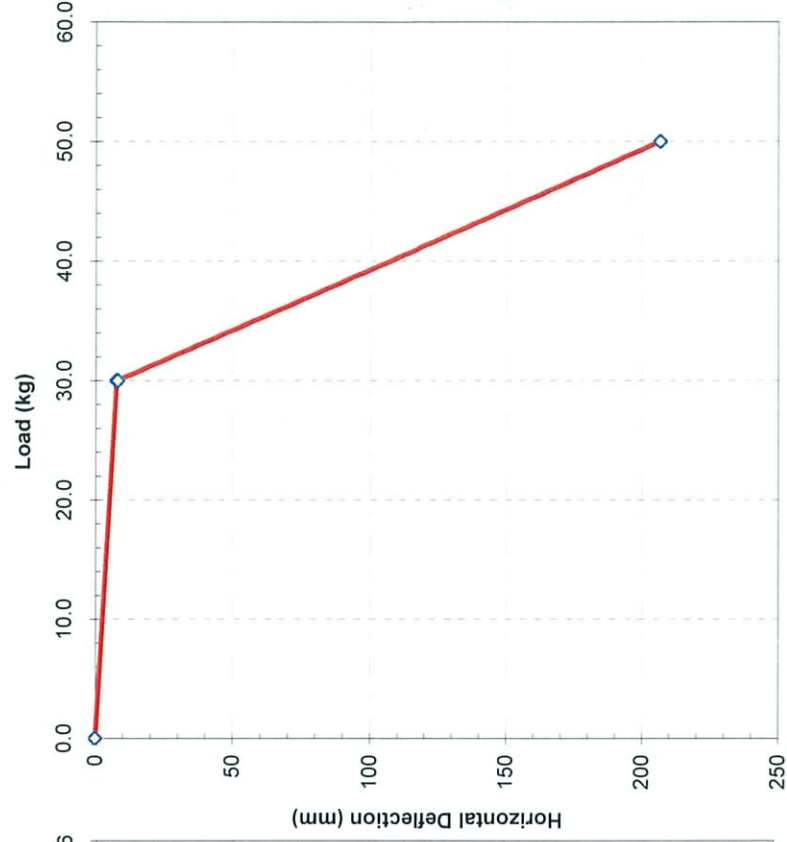
Figure No: 5A

Horizontal Load Test Results

Soil Type & Condition: Loose sand

Test Type: Driven pin at front of load frame

Horizontal Deflection vs Test Time

Horizontal Deflection vs Load

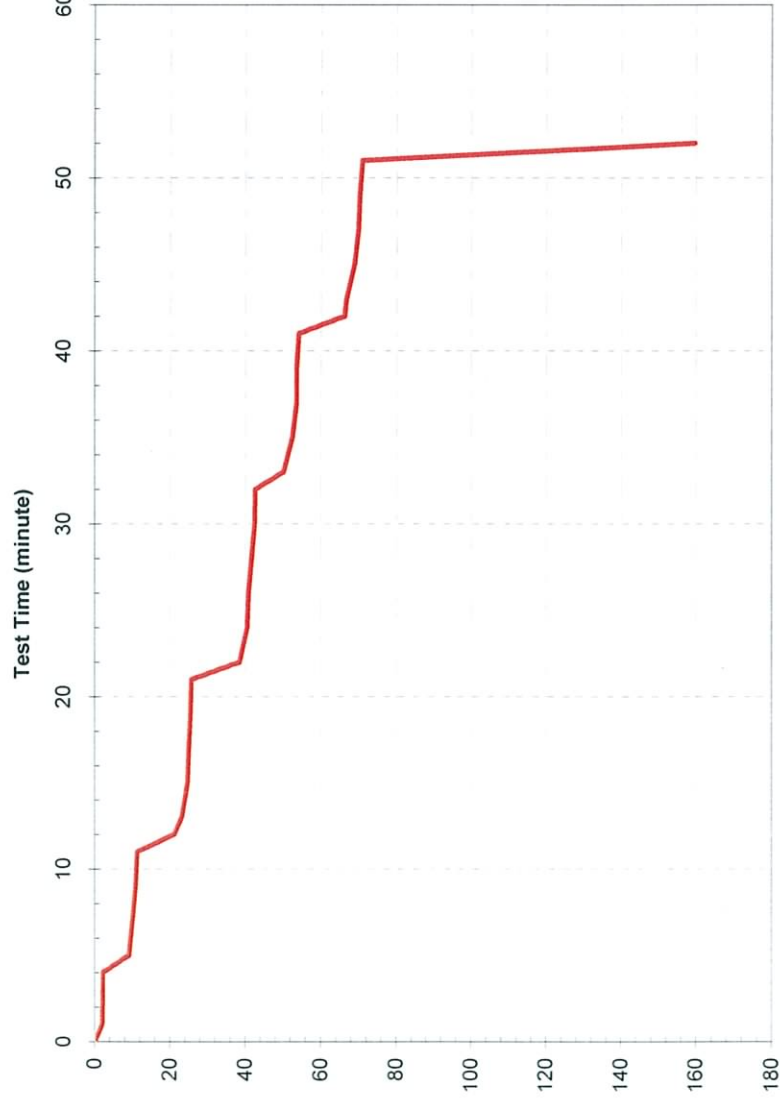
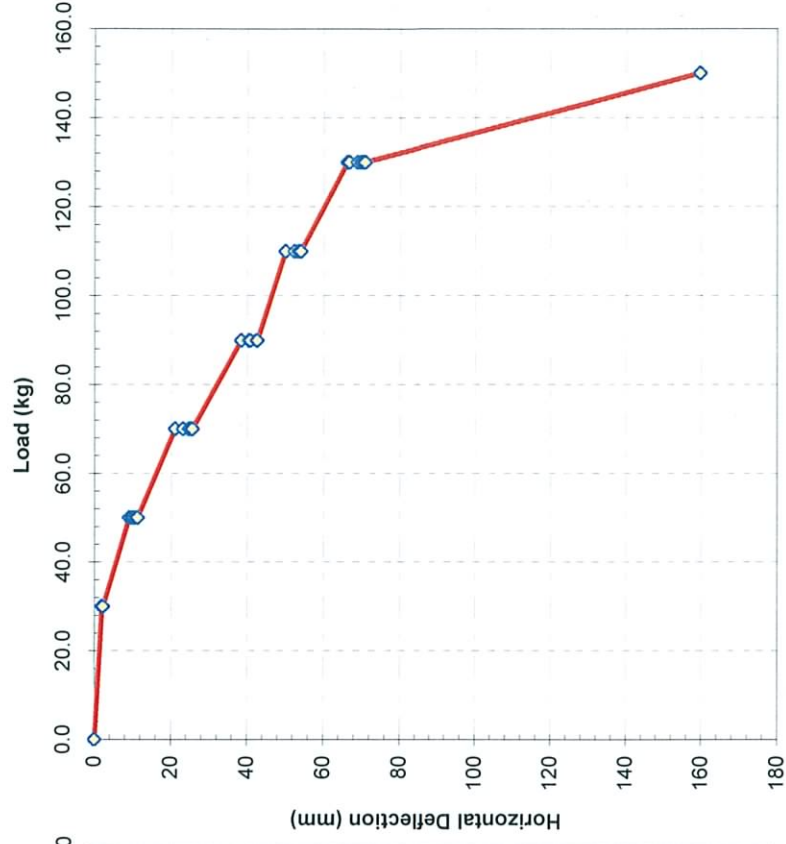
Figure No: 6A

Horizontal Load Test Results

Soil Type & Condition: Loose sand
Weather & Temperature: Sunny 30 C
Test Type: 18" Pylons
Notes:

Horizontal Deflection vs Test Time

Horizontal Deflection vs Load

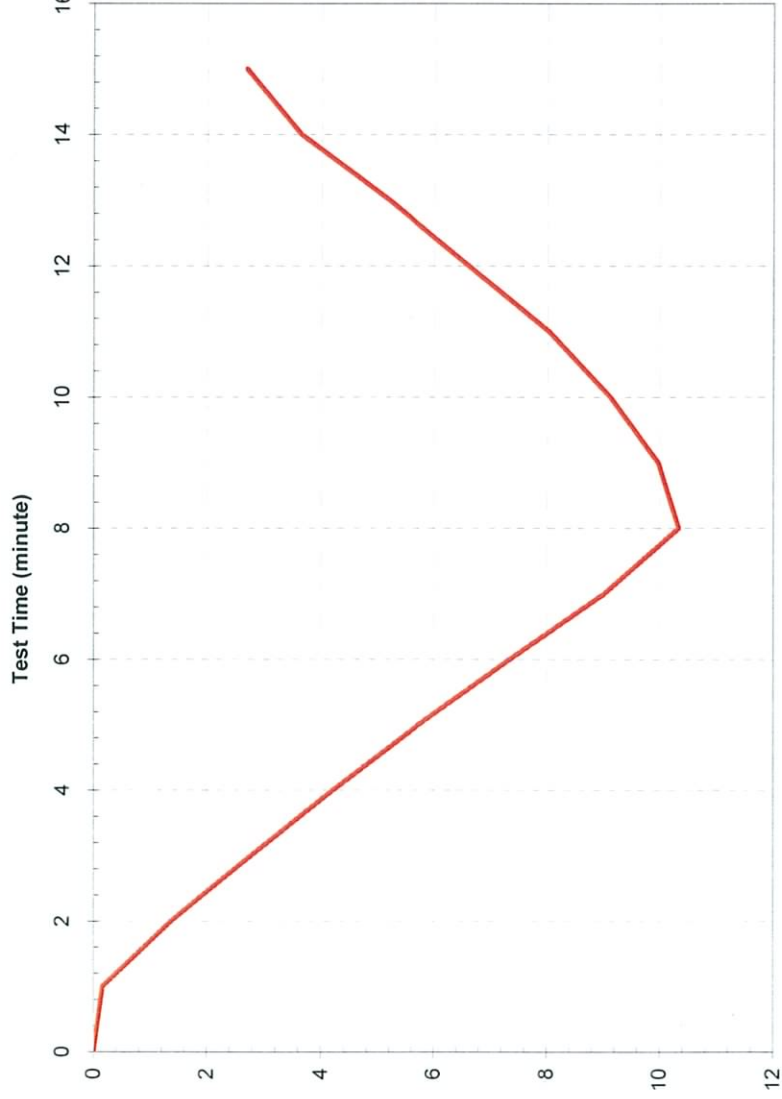
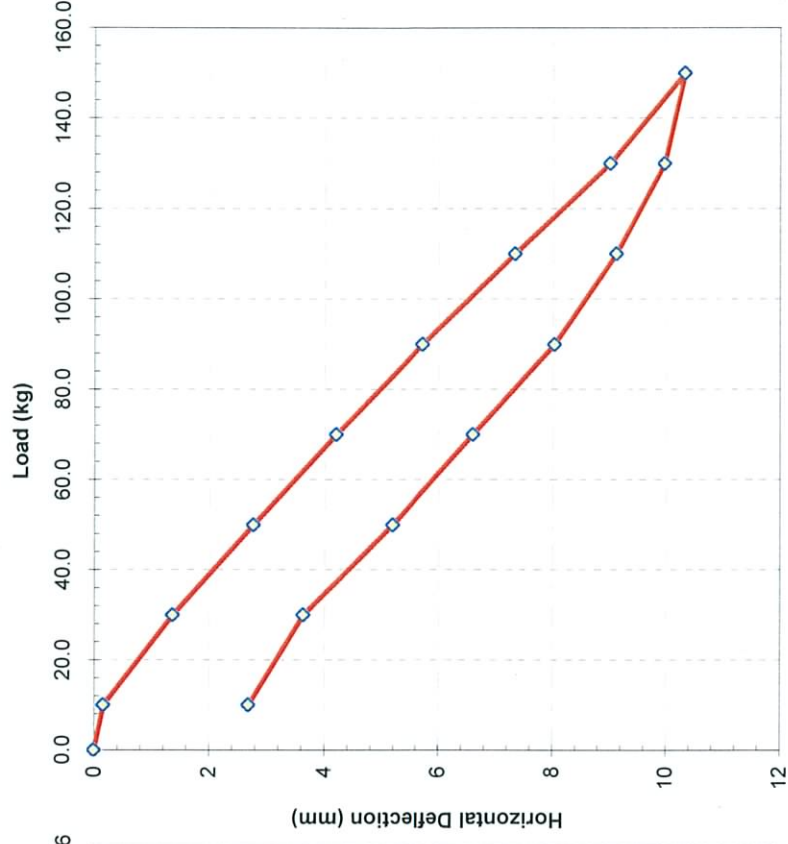
Figure No: I

Horizontal Load Test Results

Soil Type & Condition: Anchored to concrete
Weather & Temperature: Laboratory, 25 C
Test Type: Load Deflection Correction for Frame
Notes:

Horizontal Deflection vs Test Time

Horizontal Deflection vs Load

Following the above tests, a load test was carried out on the steel load frame itself by rigidly bolting the frame down onto a concrete floor slab. The load deflection relationship of the frame was then determined. Using the results of these tests corrections were then applied to the field load test data to remove the inherent flexural characteristics of the frame.

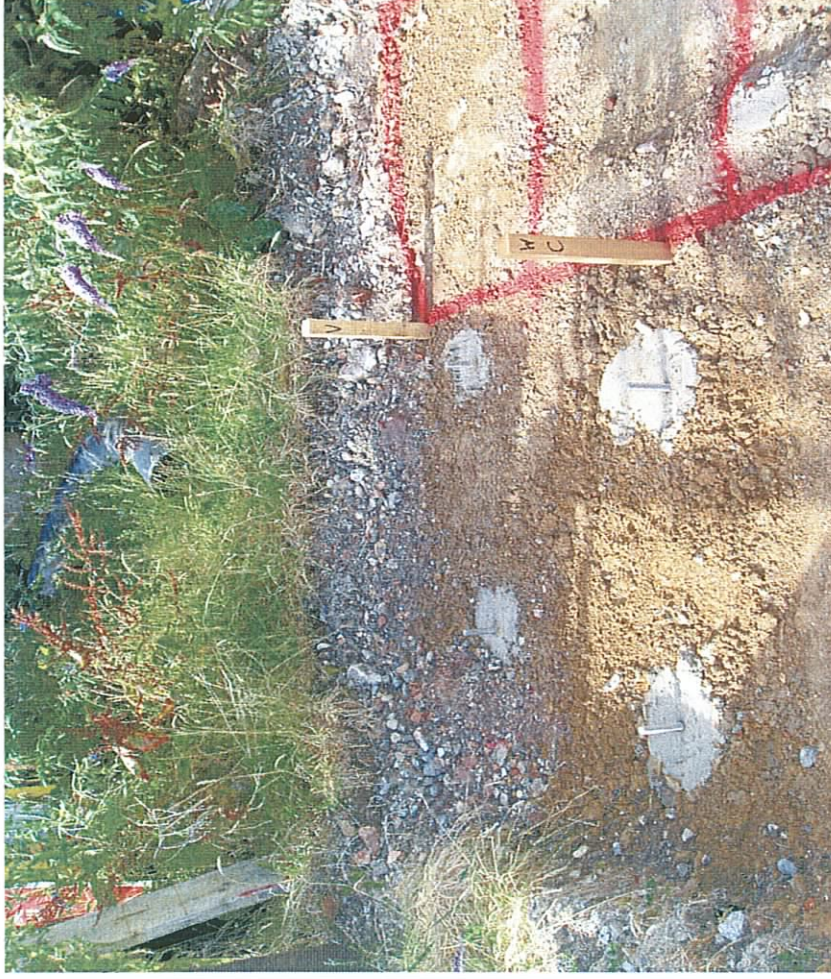
Photograph showing test area with "Pylons" Installed

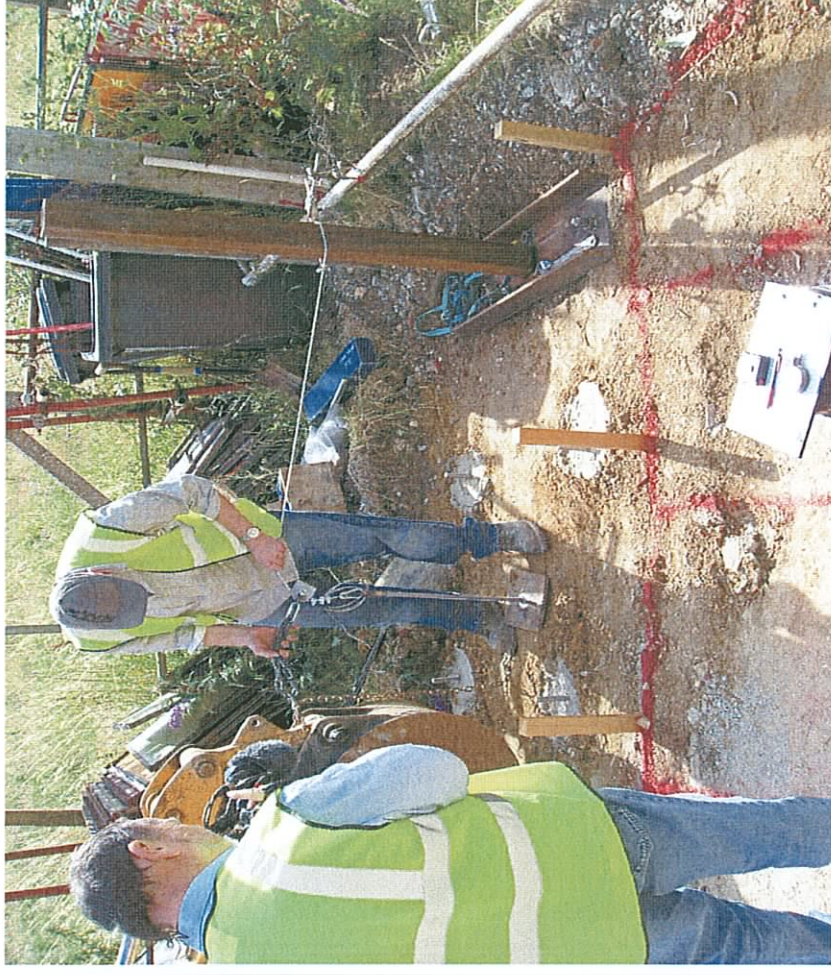
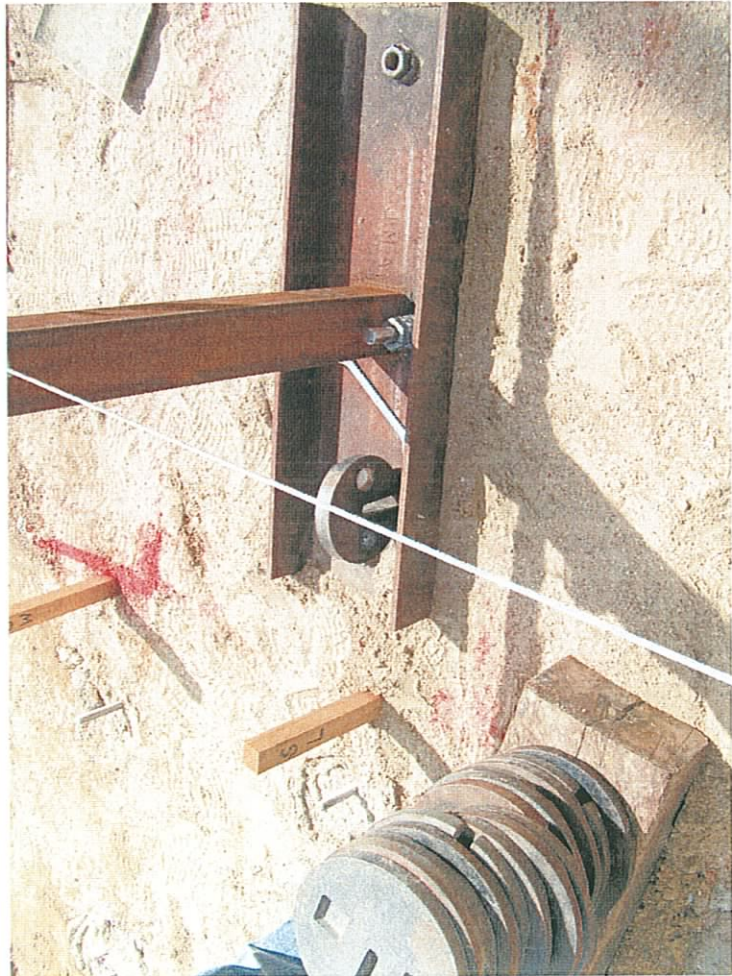
Photograph showing setting up Test

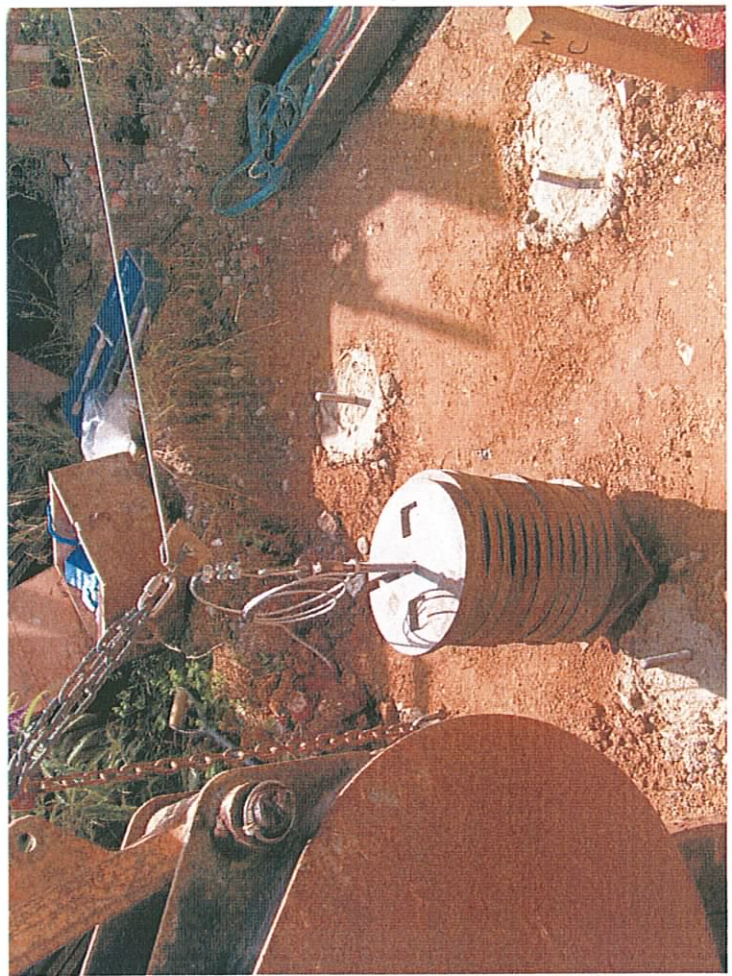
Photograph showing hanger and weights to apply horizontal load

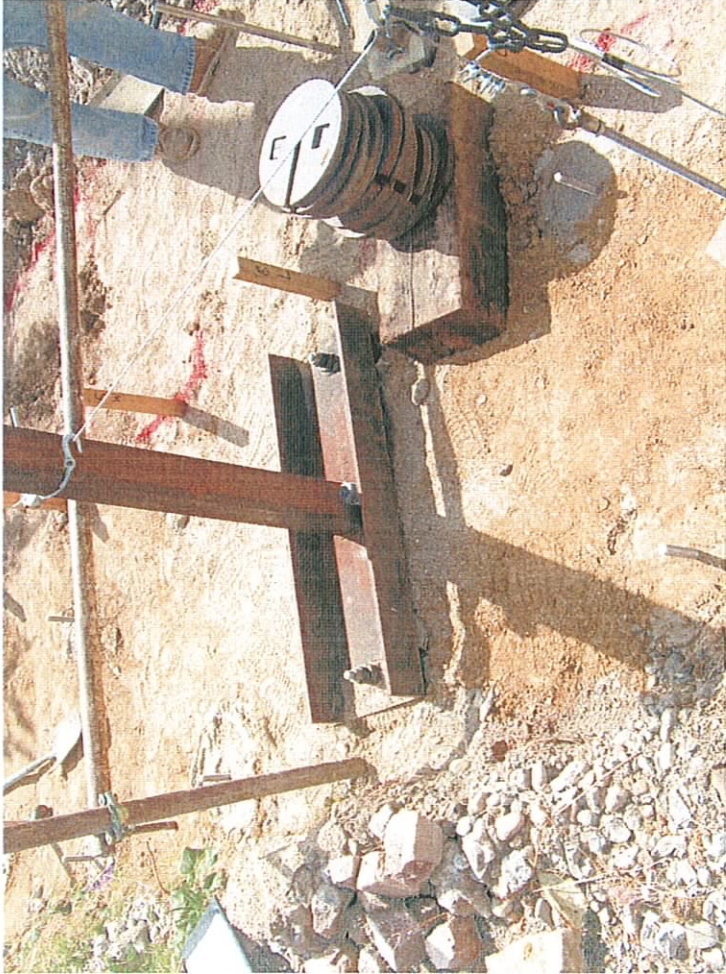
Photograph showing setting up "Pylon" Test
