Headstone Stability Load Tests

Site Address: Union Point, Uckfield, East Sussex

Client: Stone-Safe

Project Reference: J9676

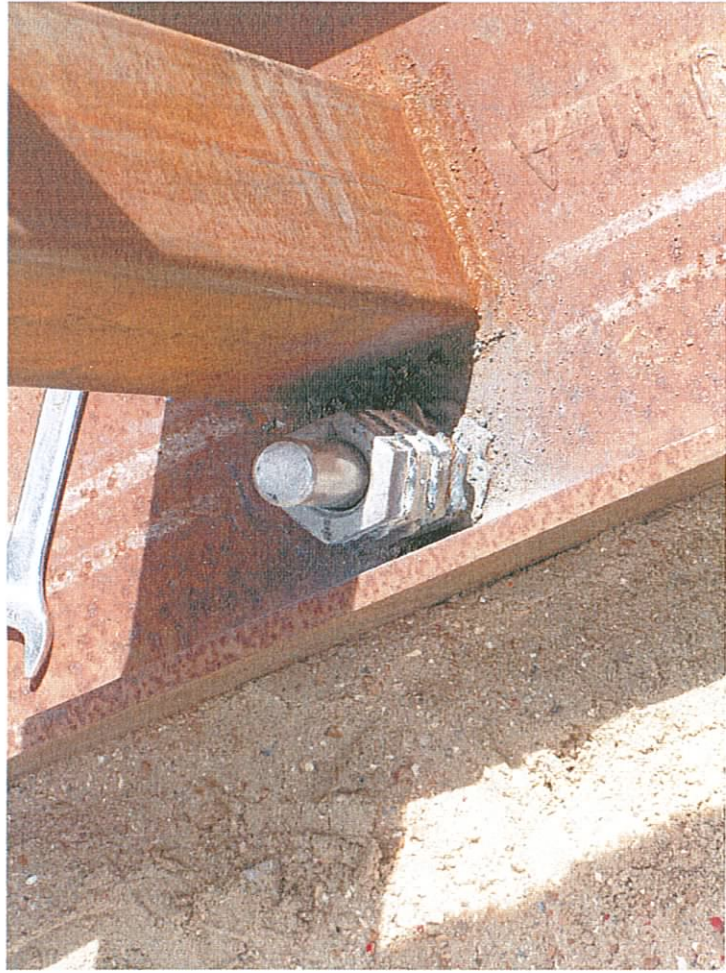
Photograph showing setting up "Pin" Test

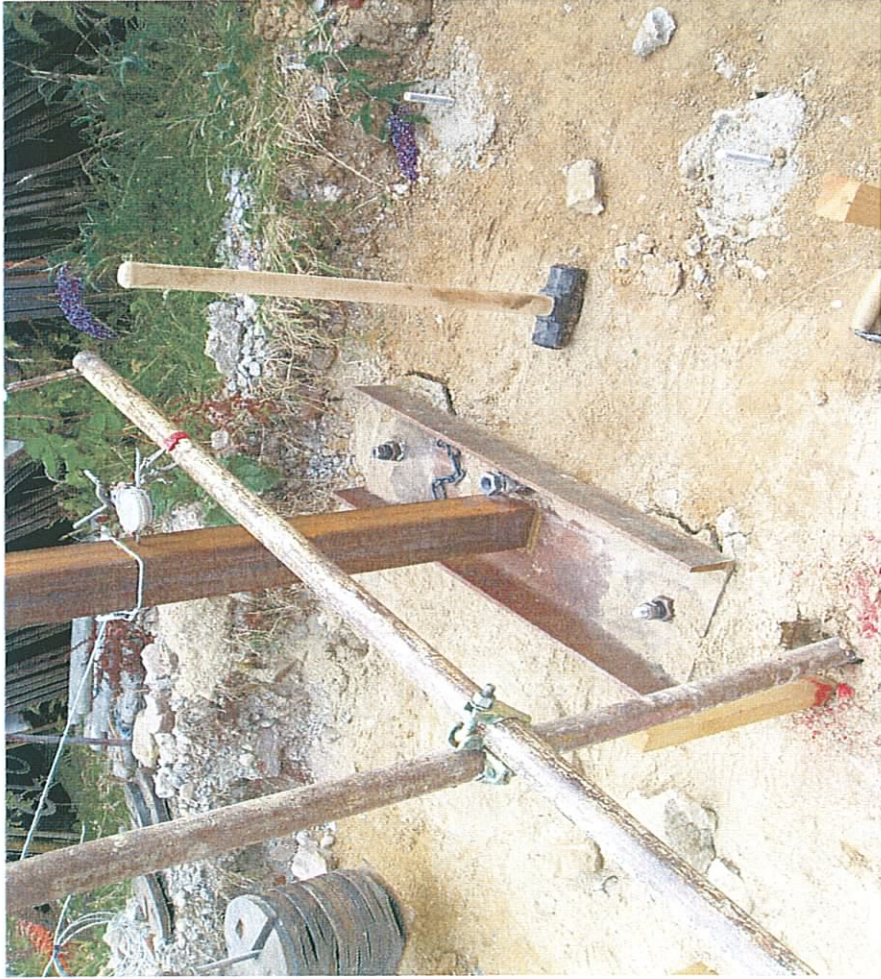
Photograph of "Pylon" Test in Very Loose Sand at Failure

It should be noted that in the case of a very loose sand condition, a minimum pile depth of 2.2' (670mm) is indicated. This is consistent with the findings of the full scale tests where the "Pylon" system effectively failed at a load increment of 130-150kg. Accordingly in cohesionless soils it would be prudent to adopt a minimum pile depth of at least 670mm for very loose cohesionless soils reducing to 550mm for very dense soil conditions.

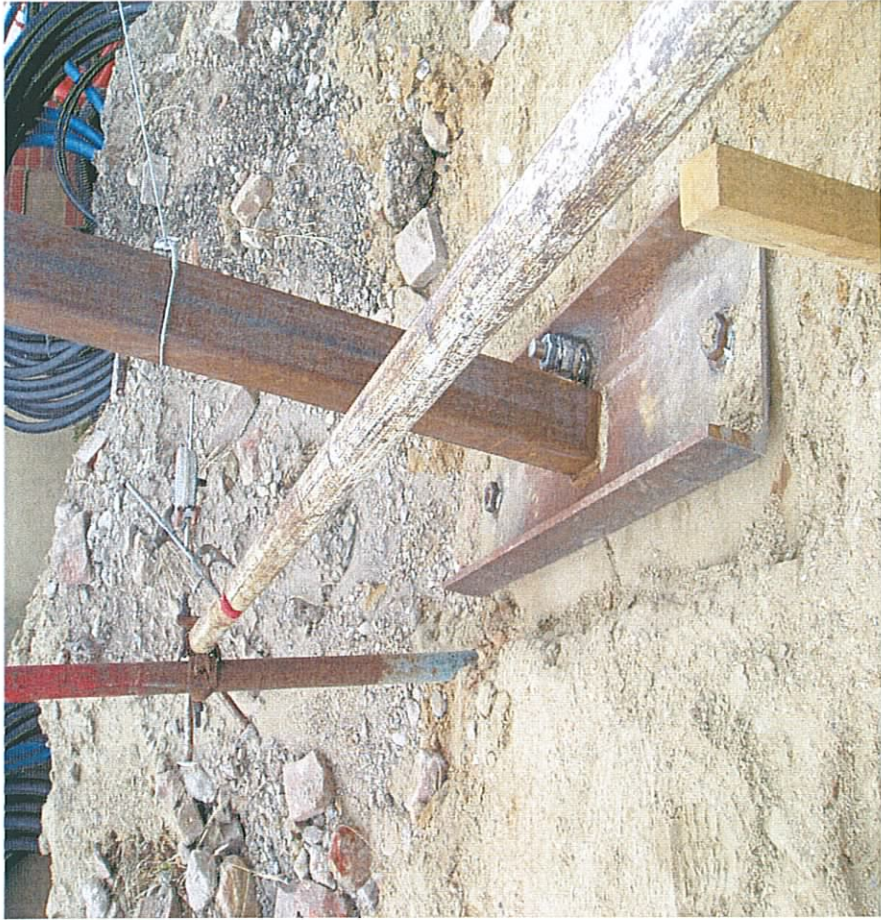
Photograph of "Pin" Test in Very Loose Sand at Failure

"Pin" System	N/A-Failure of System occurred @30-50kg load increment	N/A
