The efficacy of pin fixings for memorials brought into renewed doubt by vandal attack in Welsh cemetery

Six headstones at Ferndale Cemetery have been damaged after vandals committed the offence

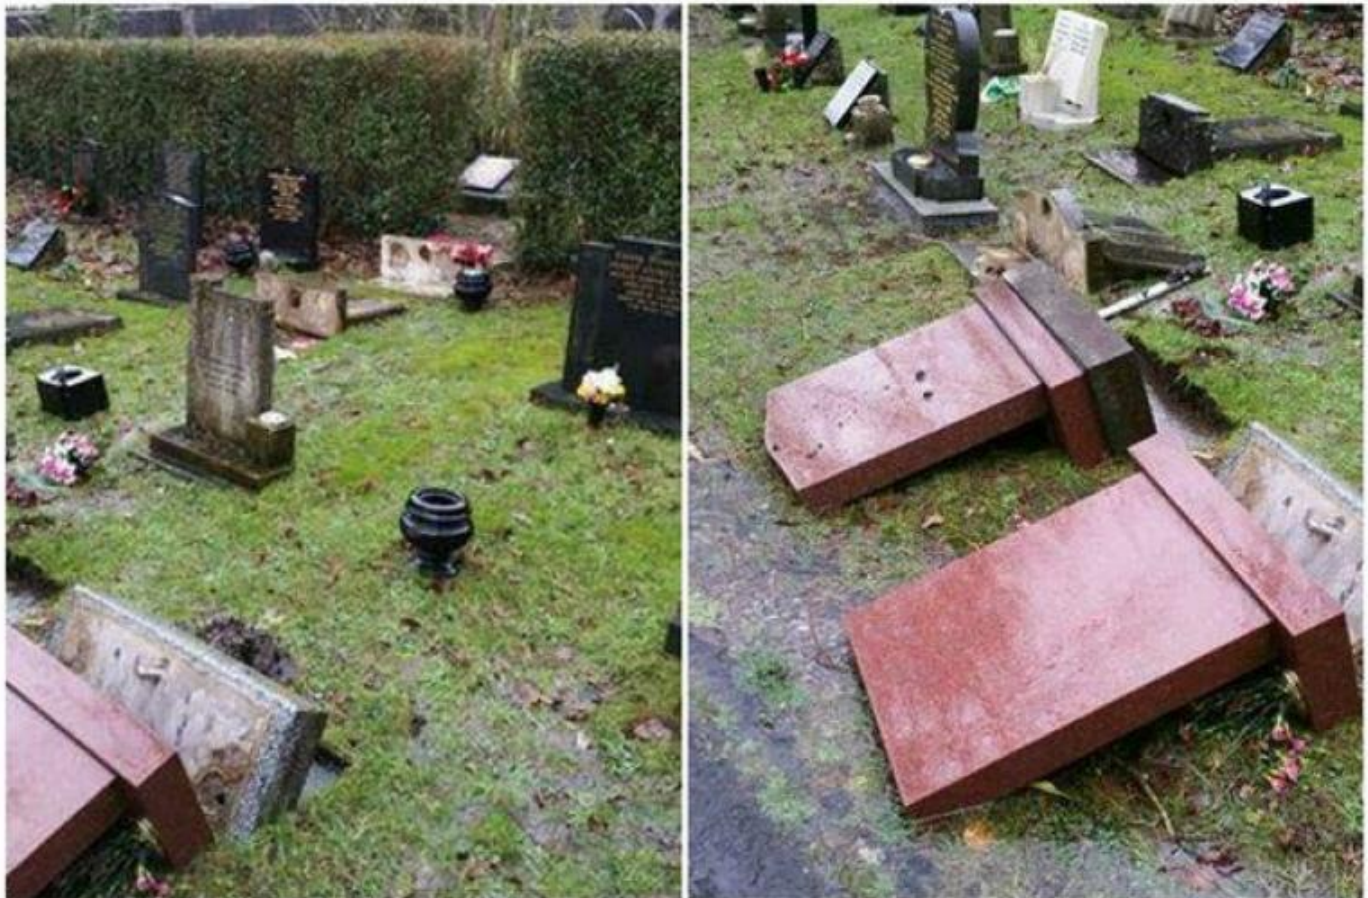
Police are appealing for information after vandals tipped over six headstones at Ferndale Cemetery

The pictures of the flattened headstones on the *Wales Online* website clearly show the pin fixings used.

The attack was in Ferndale Cemetery and reports by *Wales Online* and the BBC understandably focus on the vandalism that took place. But photographs of the flattened headstones clearly show the pins that were supposed to fasten them have, in one case, not held the stone on to the base and, in another, simply pulled out of the ground.

The conditions in the cemetery look wet. But anchors should stop headstones from toppling even in the poorest ground conditions. It is why BS 8415, the standard for fixing headstones, says the anchors should be tested in sand or gravel.

Obviously there is no indication of the force needed to push the memorials over nor whether they failed catastrophically or gradually. Nevertheless, they clearly were not held up.
